Neolithic Roofing at the Ness of Brodgar

Neil C Ackerman, Orkney College UHI

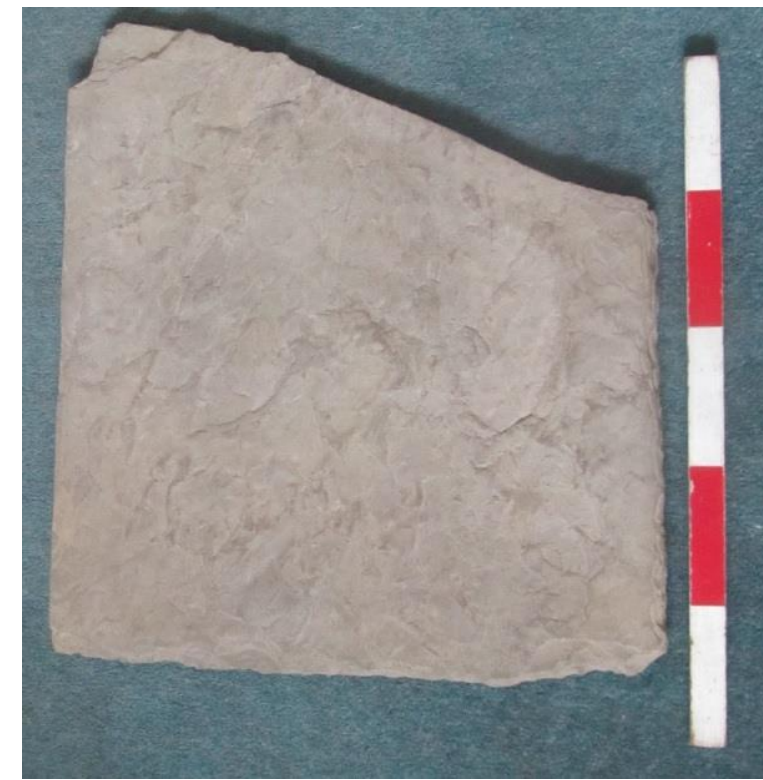
One of the flagstones from the Ness of Brodgar

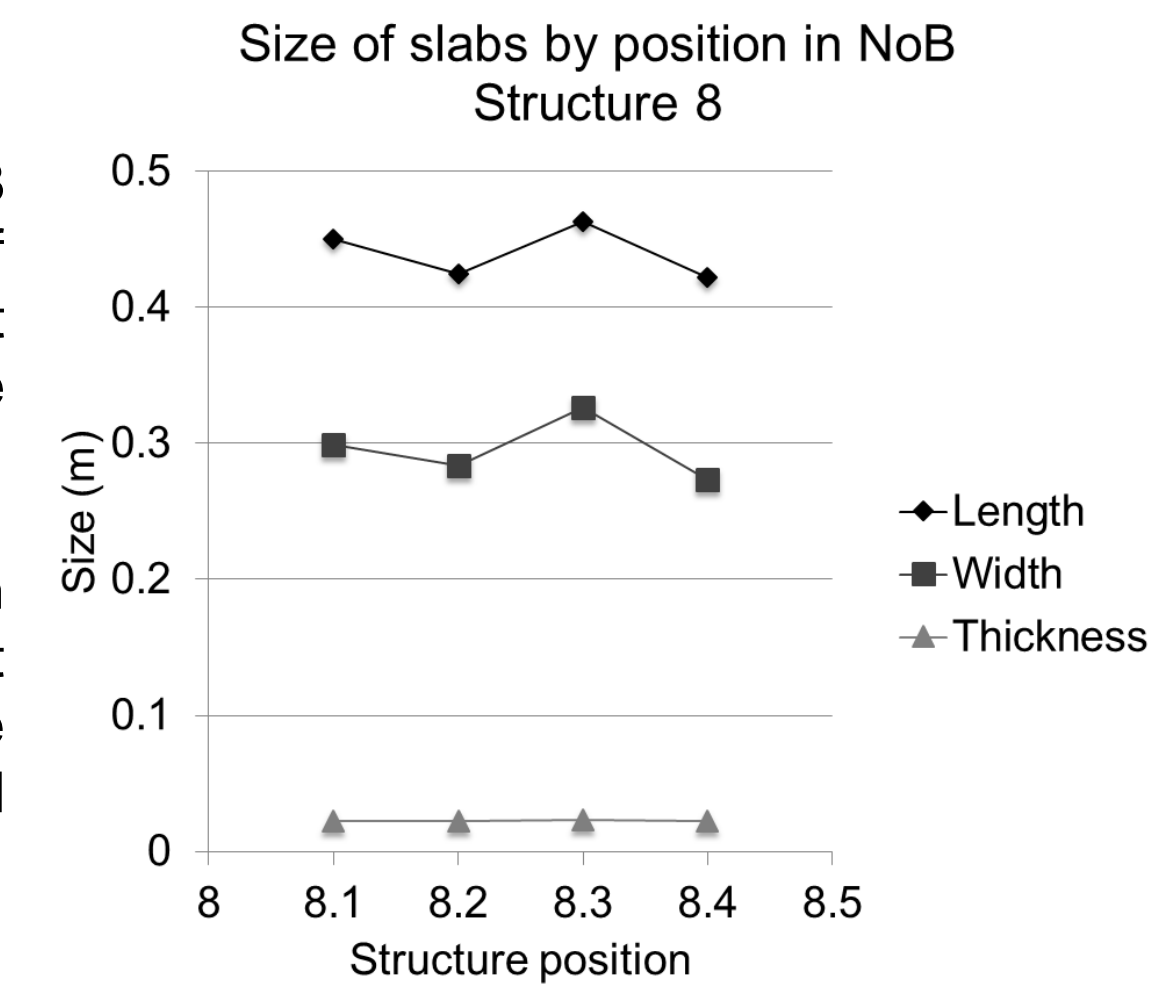
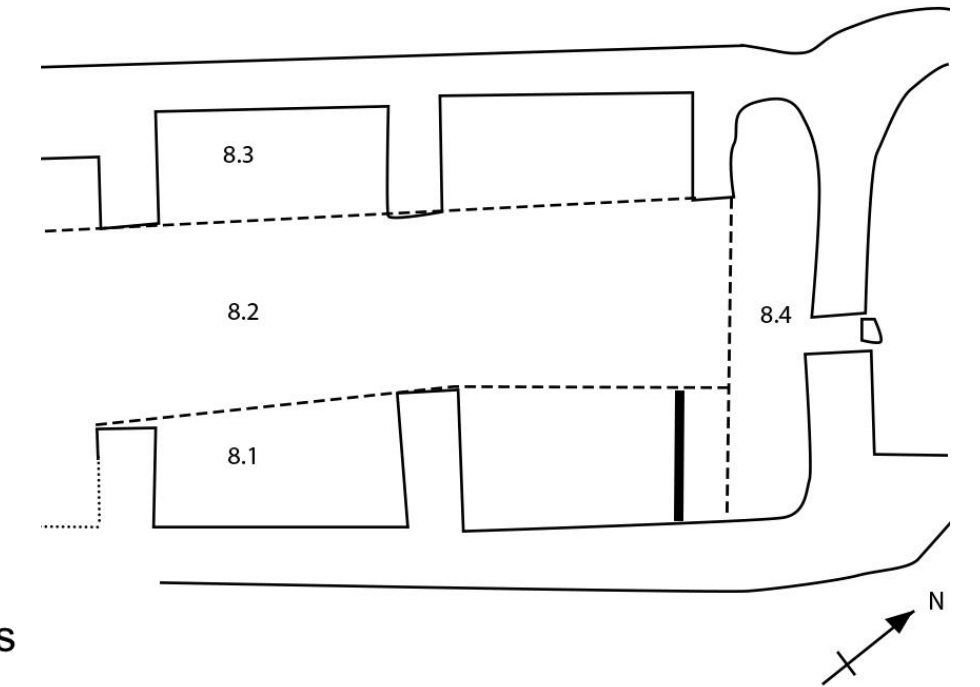
The distribution of the flagstones from the roof in Structure 8 gives hints towards the construction methodology. The size of the flagstones reduces towards the centre of the structure, but are smallest at the end wall suggesting the roof follows the curve of the wall.

Sketch plan of Structure 8 showing divisions used to understand the size by position (not to scale)

As well as showing the way the roof was built, the distribution of the flagstones also shows how it collapsed. They are not found vertically against the walls as they would likely be if the roof had deteriorated over time. Rather, they are spread across the structure with 89% lying at $\leq 45^\circ$.

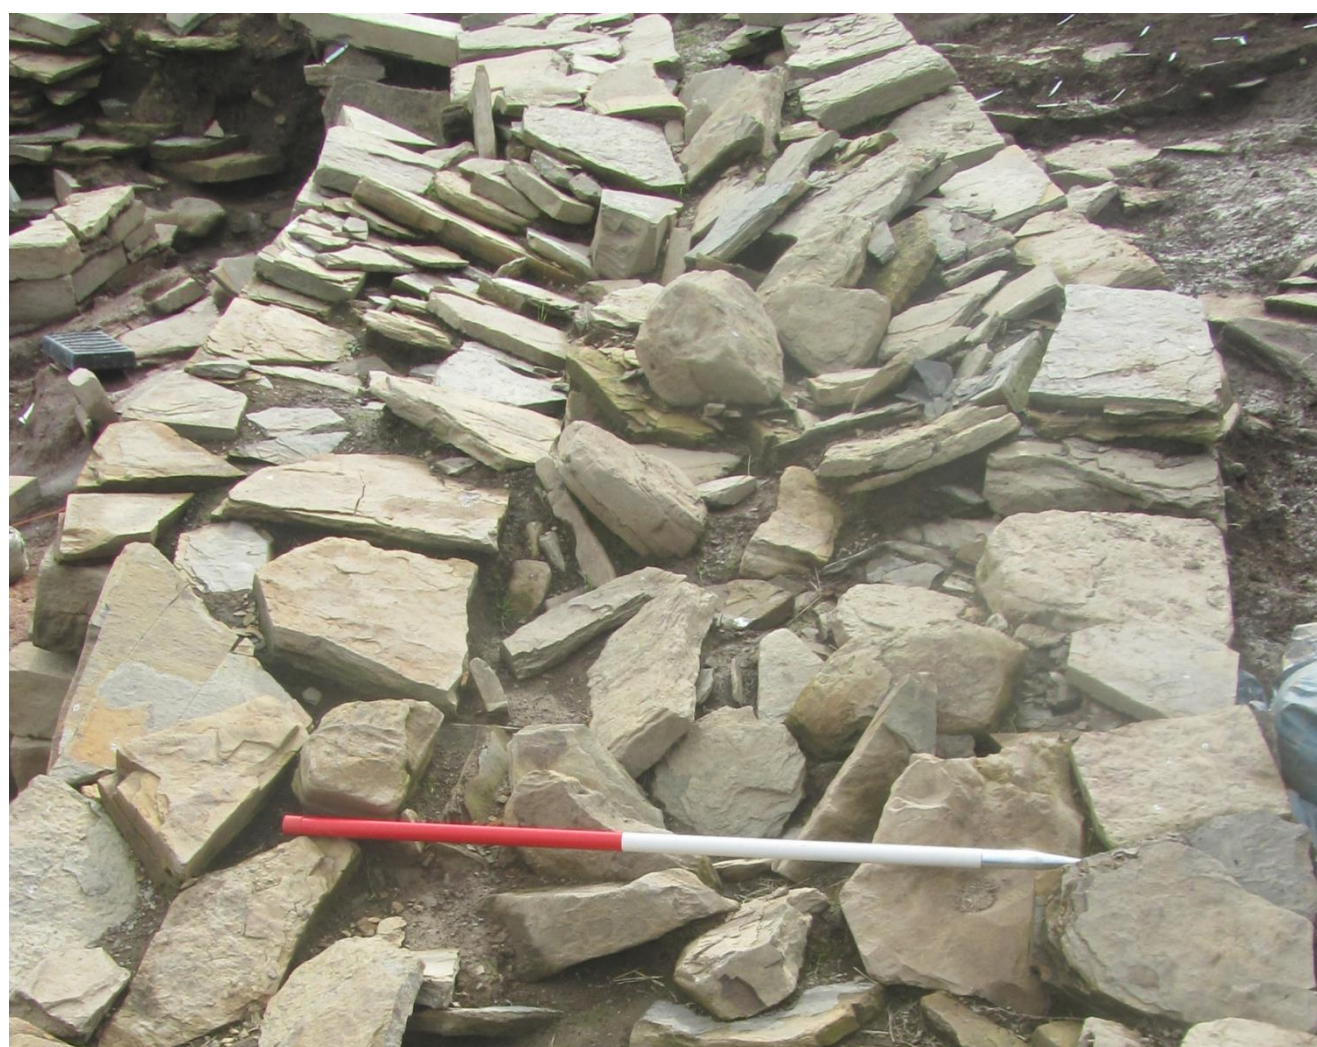
Understanding the roof furthers our understanding of the structures as a whole. The internal piers in the building could serve to shorten the unsupported span of the roof frame significantly. It also gives a possible explanation for the failure of the south west wall from Structure 12. The significant outward thrust of a roof of this size could easily cause a collapse like this if not properly countered. The shortening of Structure 1 could also be a response to a roof collapse, with the later wall being built directly on top of the collapsed material. Shortening the structure would provide less of a weight to support.

The rebuilt south west wall of structure 12

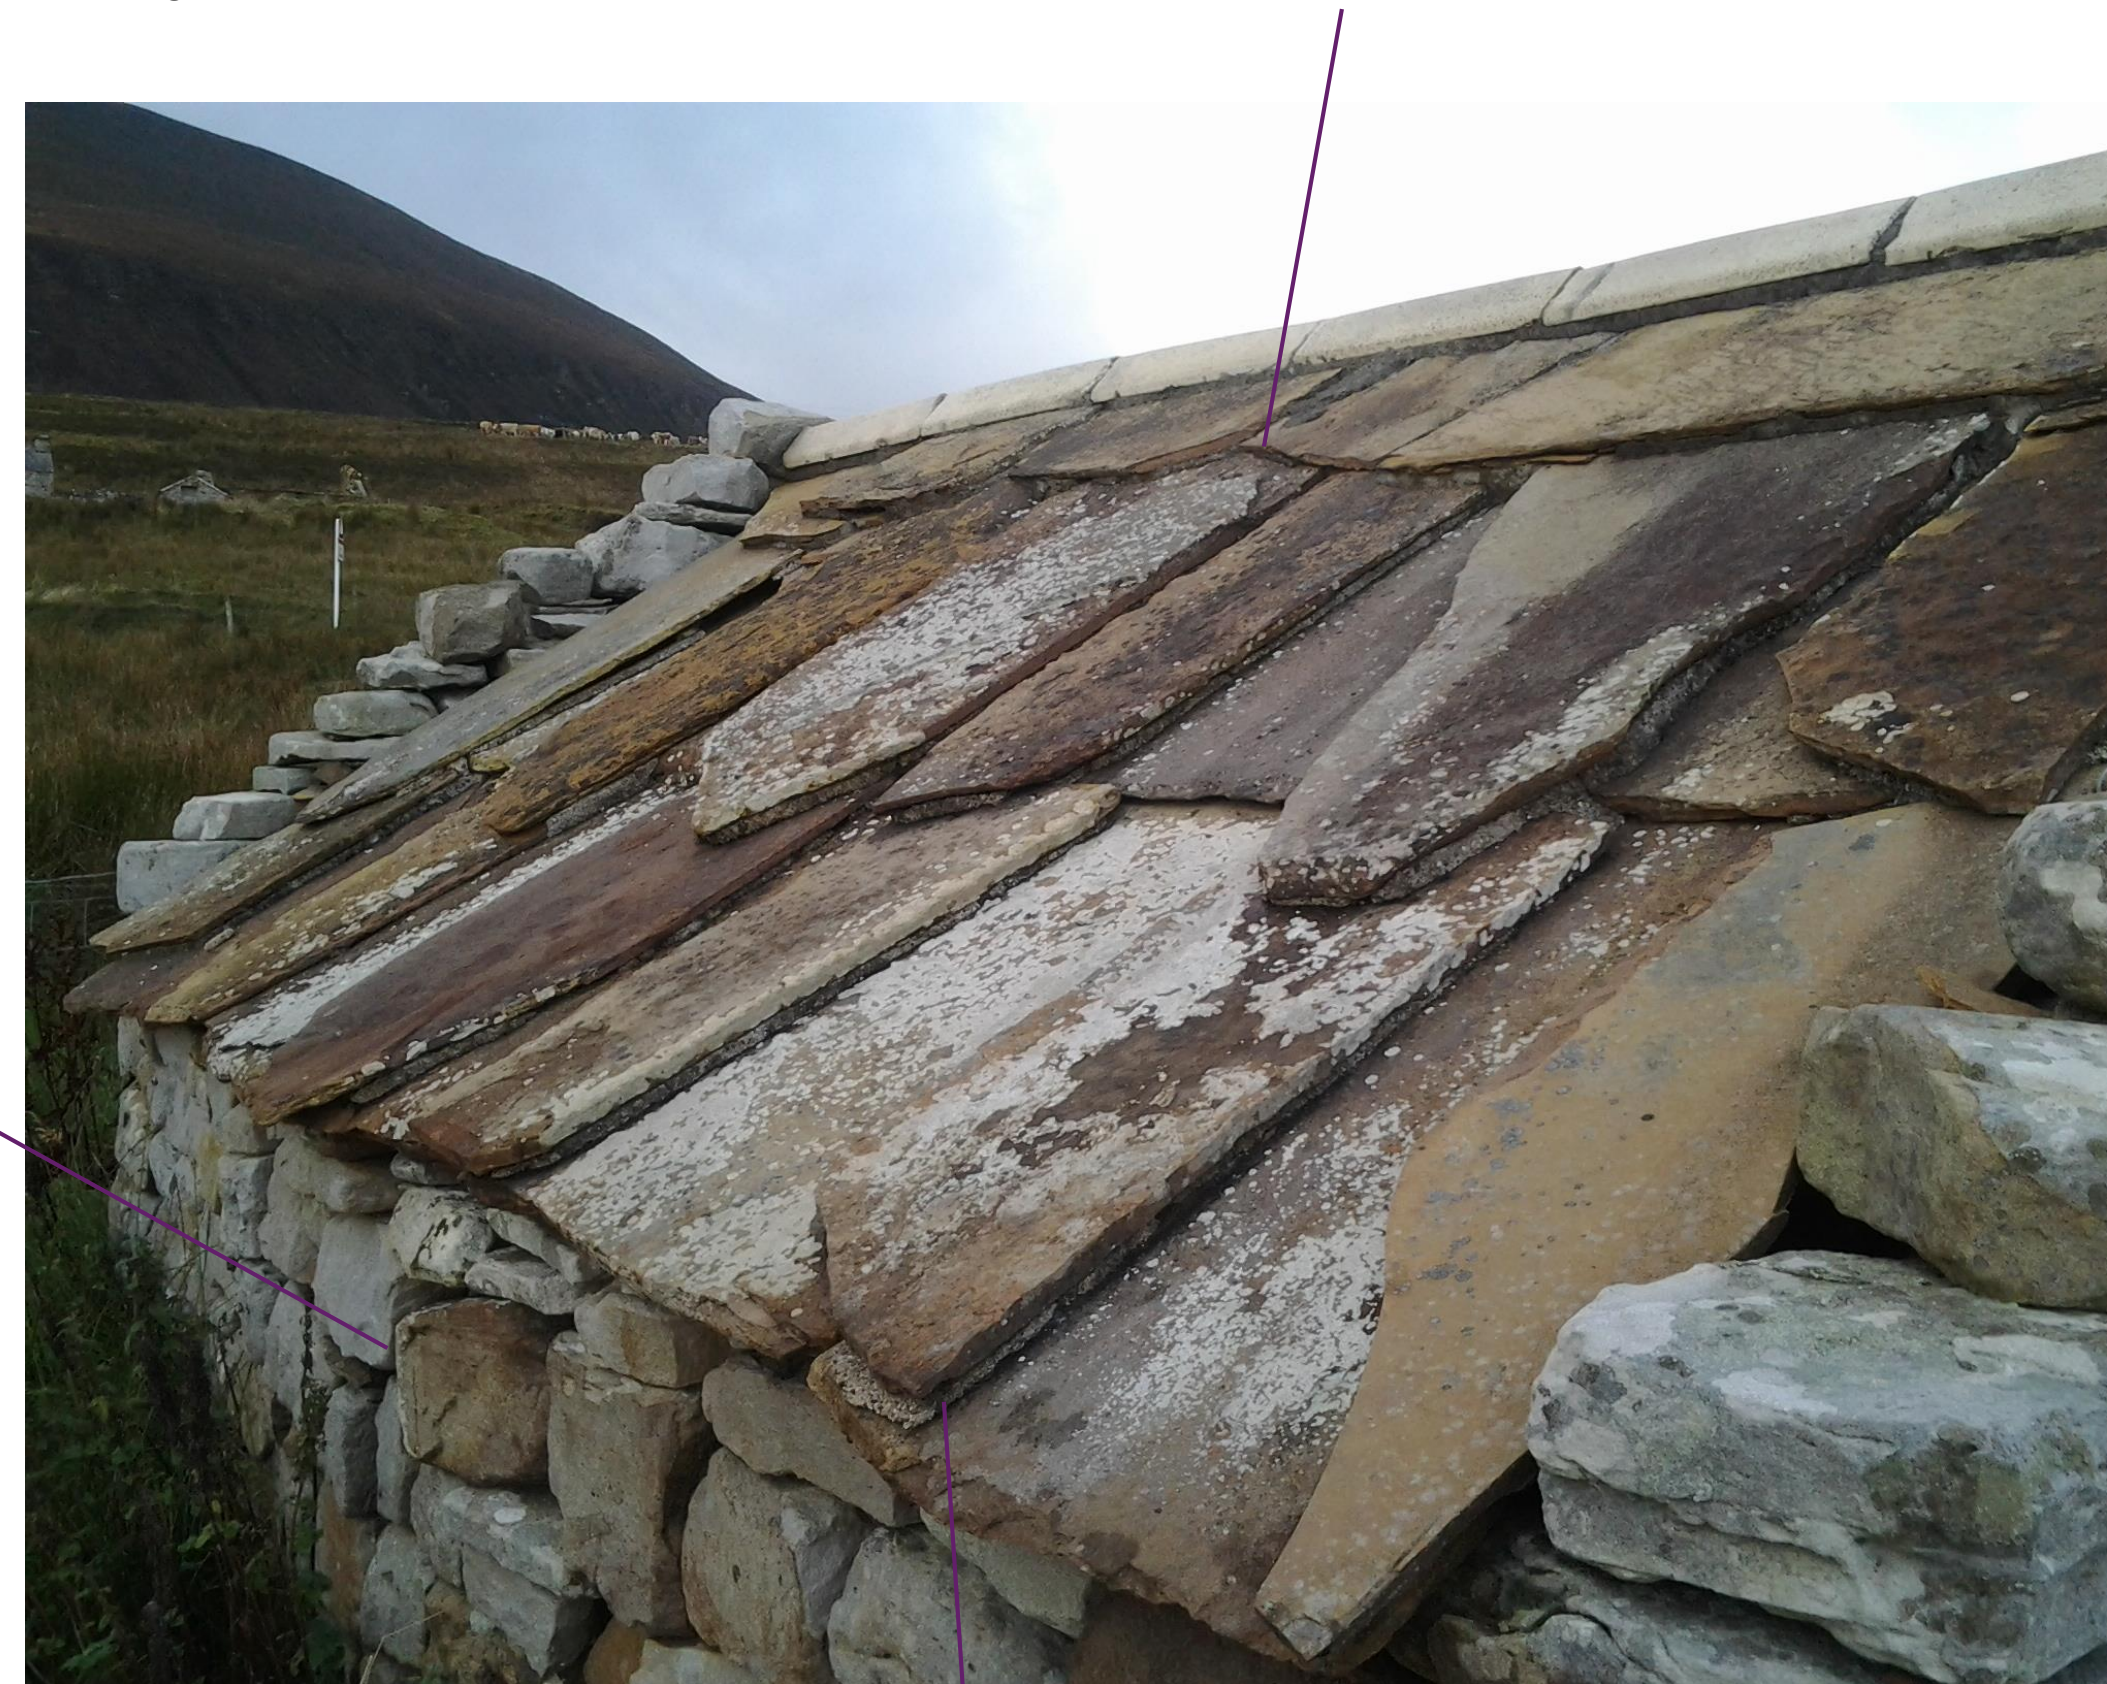
A modern flagstone roof on Hoy

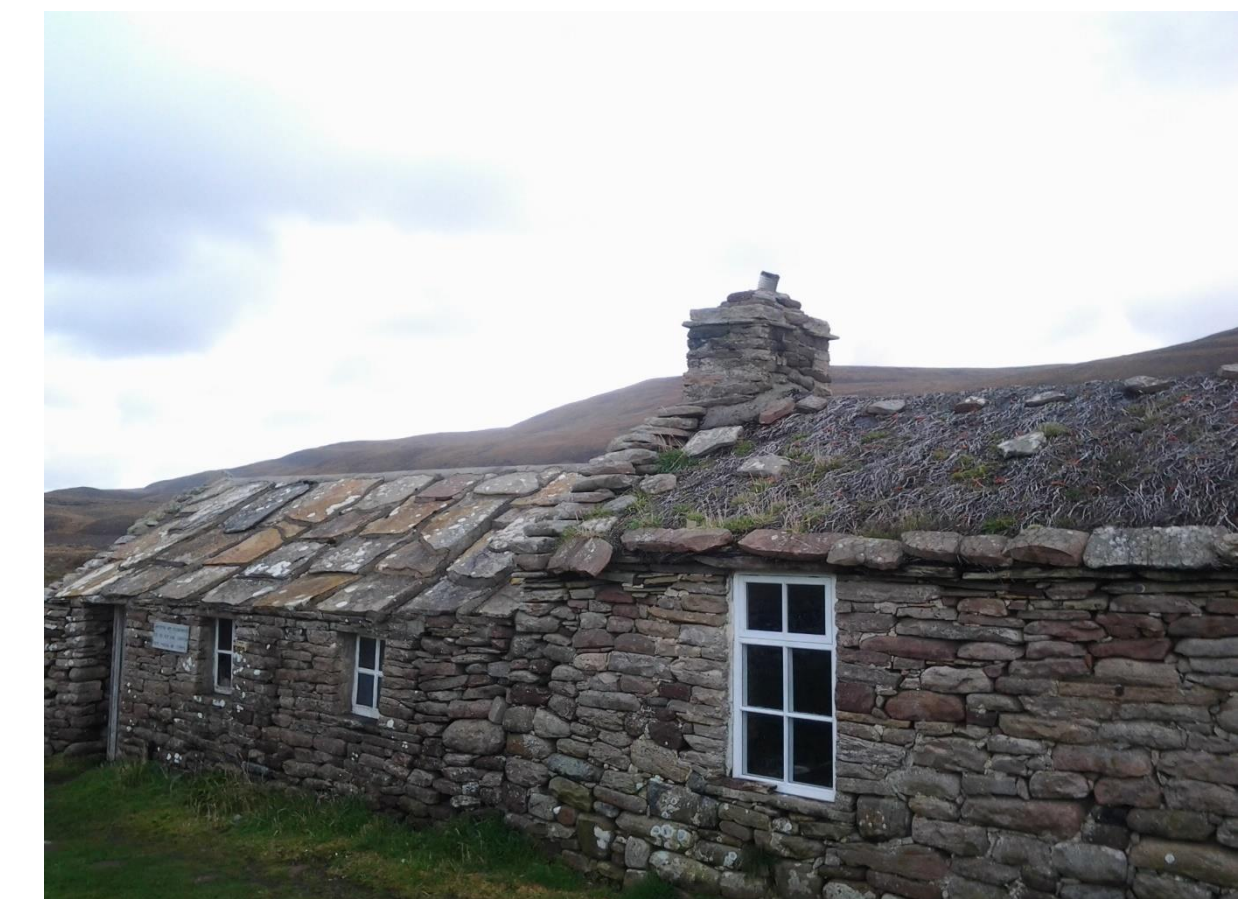
- Uncovered flagstone roof
- Covered flagstone roof
- Partial flagstone roof

Bothy in Rackwick showing suggested models a) to the left and b) to the right

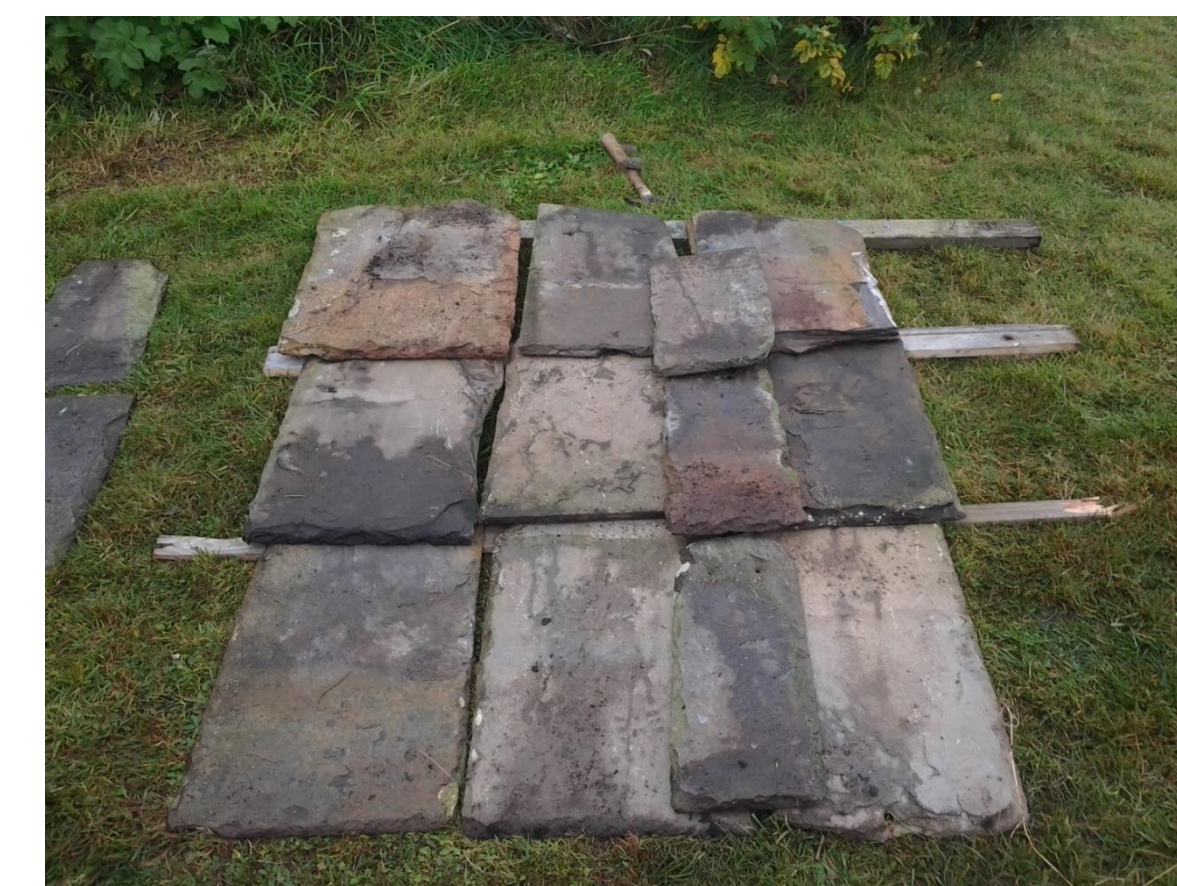
Large amounts of compact white clay were found with the flagstones when they were excavated. This could serve as a caulking material, as well as keeping the flagstones together. An internal covering is also highly likely, as there is no evidence of direct exposure to the smoke and soot from the internal hearths. A seamer method (like the one shown on the right) was used to cover the gaps between flagstones and reduce the amount of moisture getting into the structure.

Reconstruction flagstone roof showing seamer method
